April 27, 2021

Version 1

Warranty Extension: 2016-20 HR-V CVT Premature Belt Deterioration

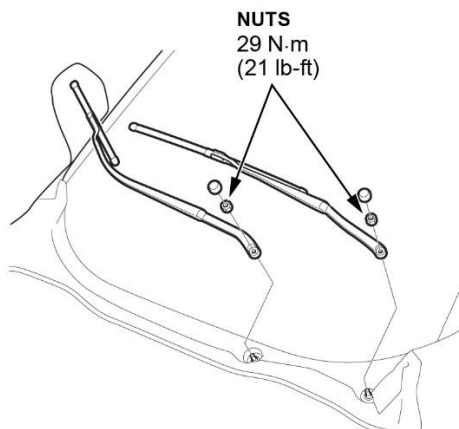
1. Remove wiper arms and cowl cover.

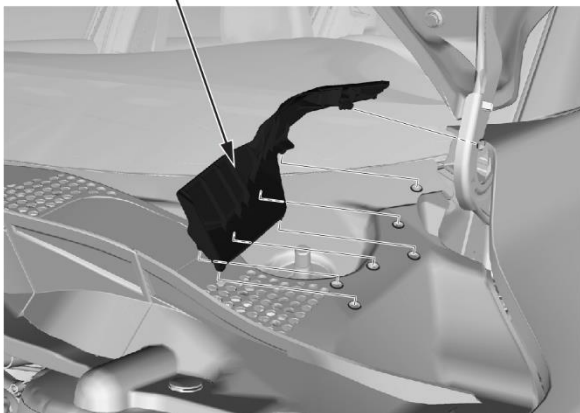
FRONT FENDER COVER

2. Remove the left and right front fender covers.

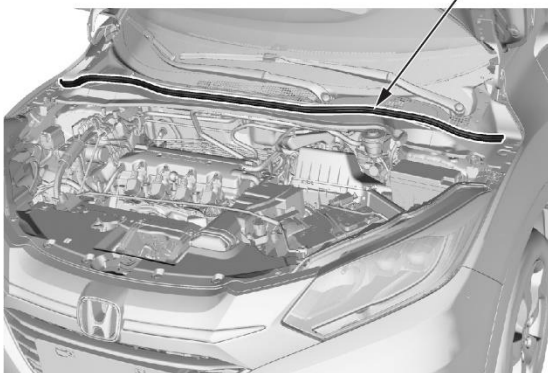
HOOD REAR SEAL

3. Remove the hood rear seal.

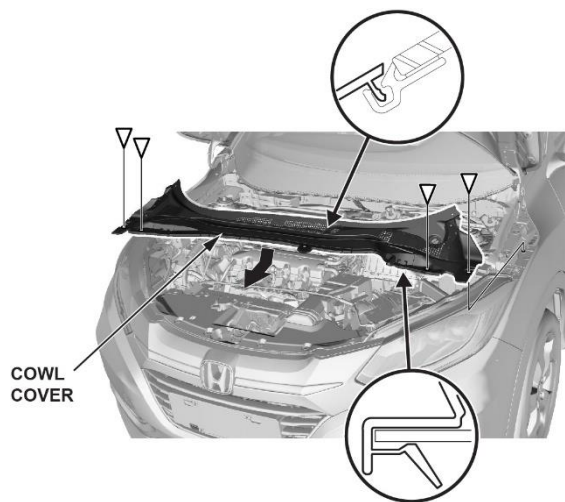
4. Remove the cowl cover.

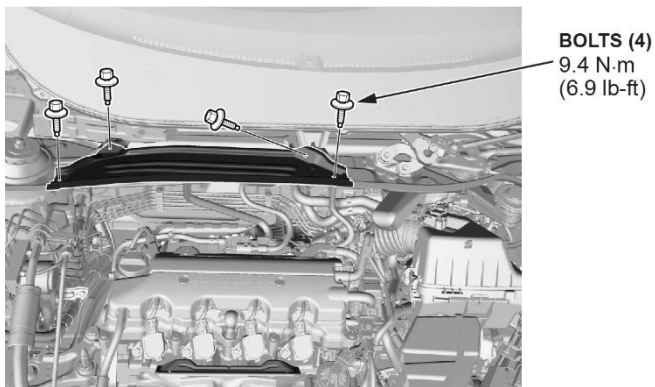
5. Remove the dashboard upper lid.

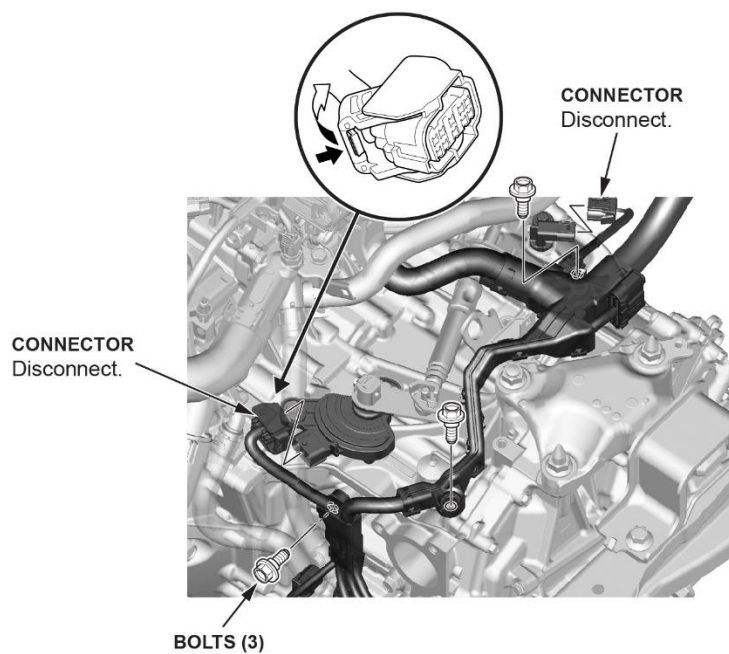
11. Remove the bolts and disconnect the connectors.

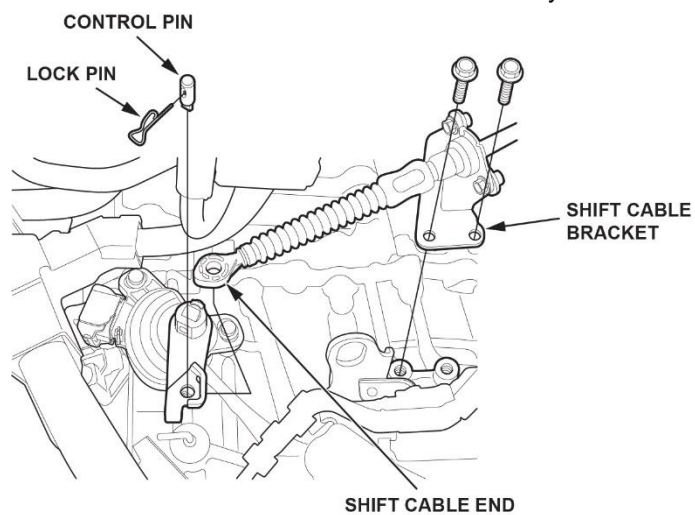
12. Remove the lock pin, control pin, shift cable bracket, shift cable, and engine wire harness.

NOTE: Do not bend the shift cable excessively.

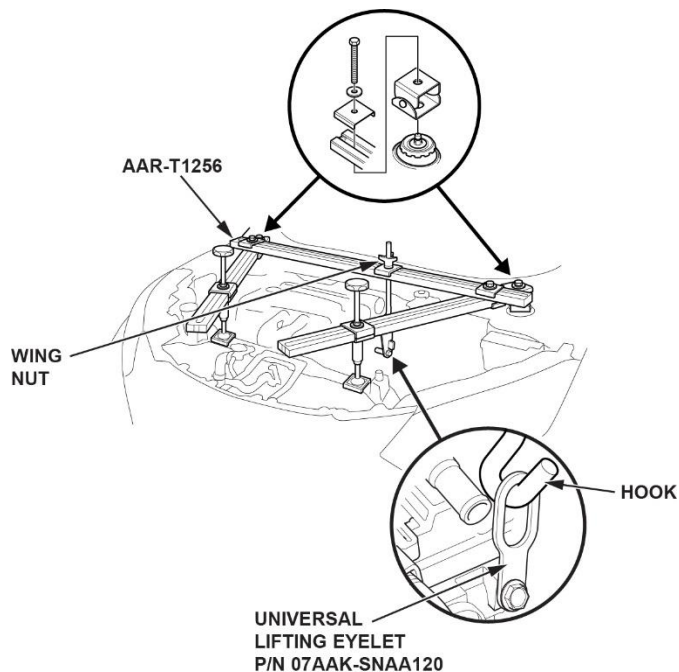
16. Install the engine support hanger, then attach the hook to the slotted hole in the universal lifting eyelet. Tighten the wing nut by hand and support the engine/transmission.

NOTE: Be careful when working around the windshield.

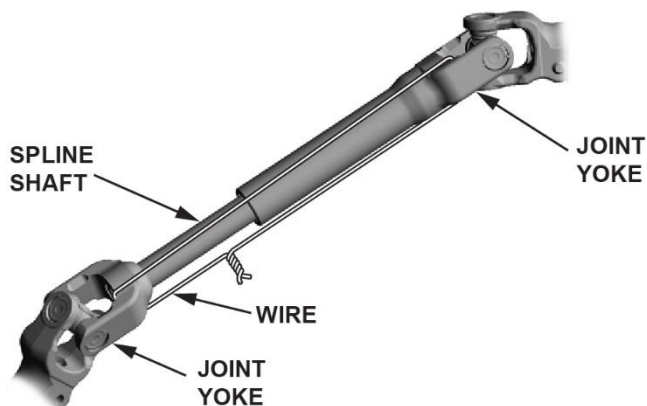
22. Hold the spline shaft on the column with a piece of wire between the joint yoke of the spline and the joint yoke of the spline tube to prevent the lower spline shaft from coming out.

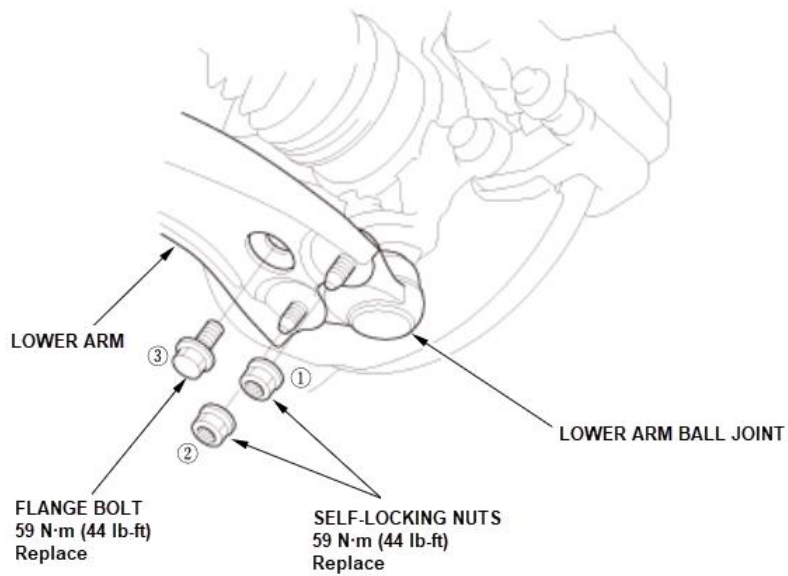
26. Remove the flange bolt and self-locking nuts, then disconnect the lower arm from the lower arm ball joint.

- Use new self-locking nuts and the flange bolt during reassembly.
- Tighten the self-locking nuts and the flange bolt in the sequence shown.

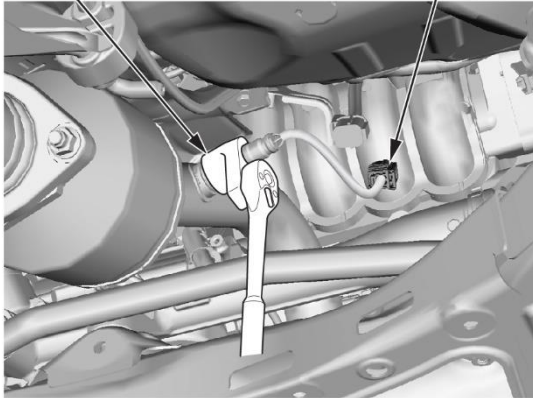
28. Disconnect the connector and remove the secondary HO2S.

SECONDARY HO2S
45 N·m (33 lb-ft)

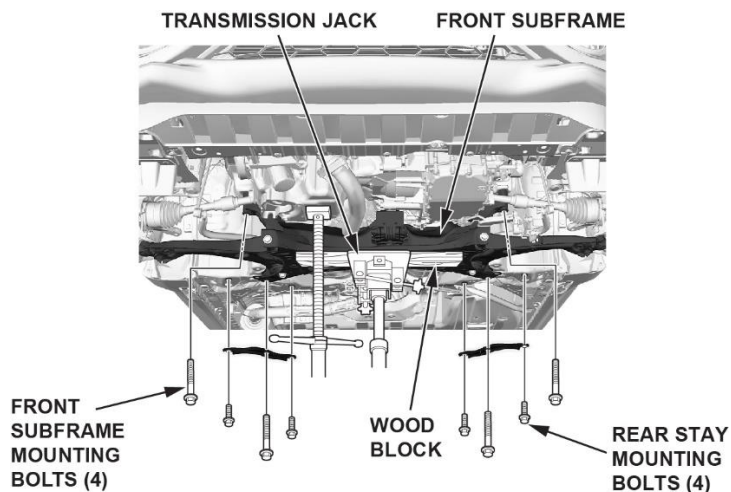
32. Attach a wood block (A) to the lower center of the front subframe, attach a transmission jack (C) to the center of the wood block. Support the front subframe securely by raising the transmission jack, remove the front subframe mounting bolts (D) and the subframe rear stay mounting bolts (E).

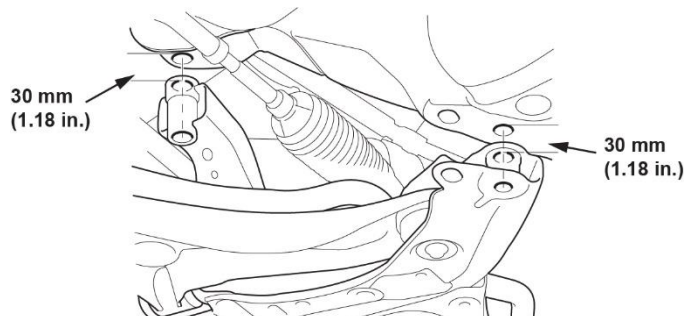
33. Lower the jack slowly until the subframe of the body has dropped about **30 mm**.

NOTE: Do not lower the subframe more than required.

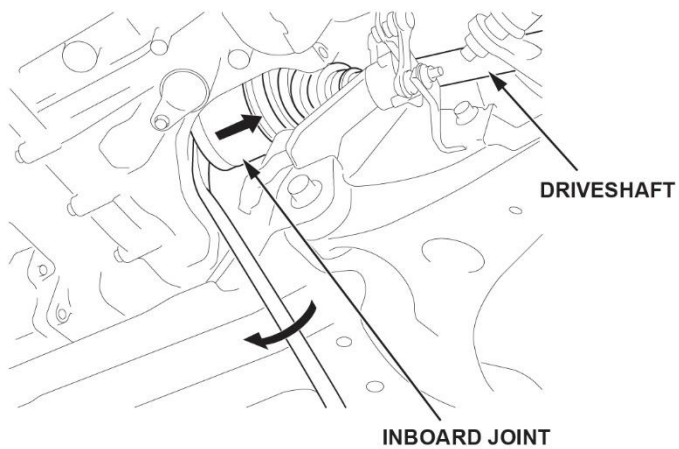
LEFT DRIVESHAFT

48. Disconnect the left driveshaft inboard joint and secure the driveshafts to the body with straps.

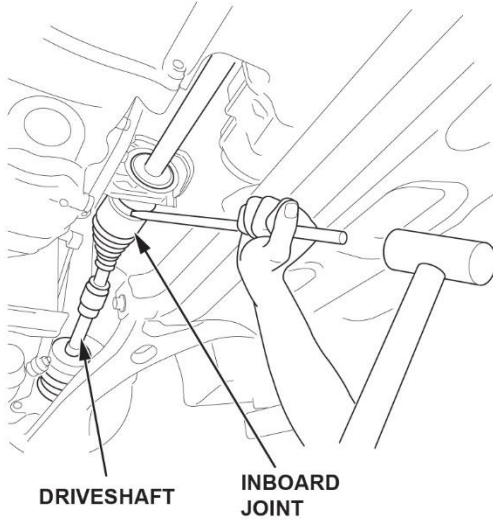
RIGHT DRIVESHAFT

49. Disconnect the right driveshaft inboard joint and secure the driveshaft to the body with straps.

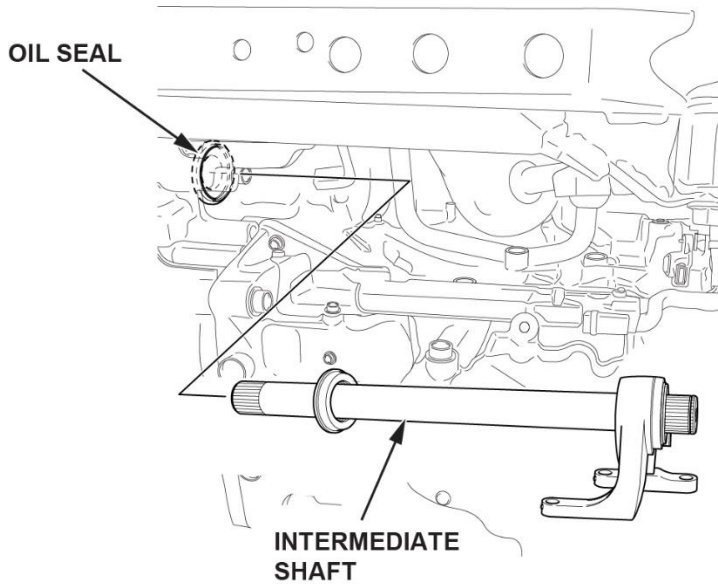
51. Remove the intermediate shaft.

NOTE: Hold the intermediate shaft horizontal until it is clear of the differential to prevent damaging the oil seal.
